Macondo Well-Deepwater Horizon Blowout: Lessons for Offshore Drilling Safety

Macondo Well–*Deepwater Horizon* Blowout: Lessons for Improving Offshore Drilling Safety

Committee for Analysis of Causes of the Deepwater Horizon Explosion, Fire, and
Oil Spill to Identify Measures to Prevent Similar Accidents in the Future

NATIONAL ACADEMY OF ENGINEERING *AND*
NATIONAL RESEARCH COUNCIL

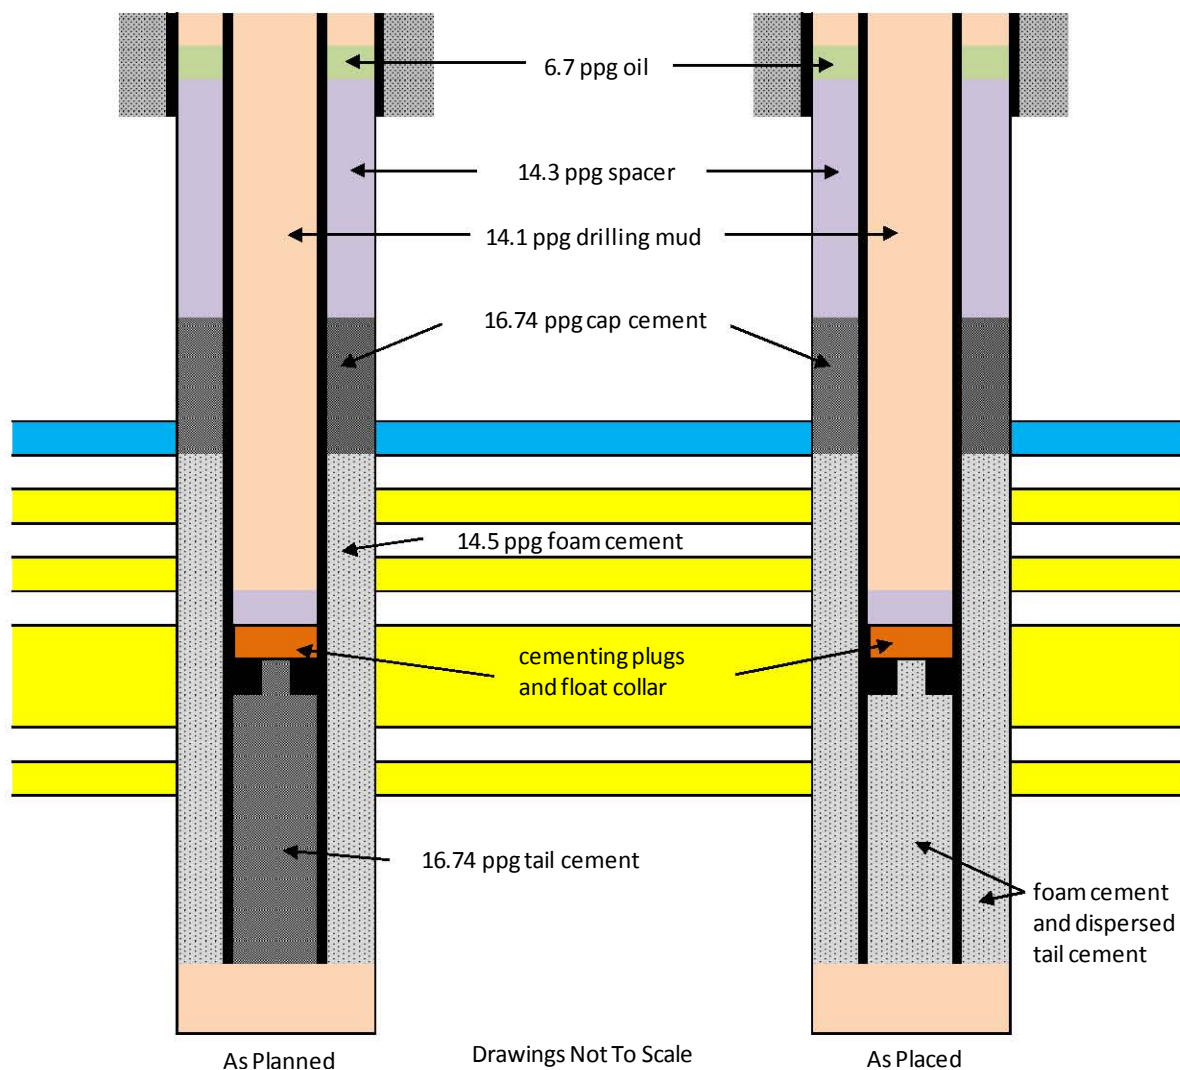
FIGURE 2-5 Planned cement location and likely cement location after pumping. Source: Committee.

The last of the cement (tail cement) was to be un-foamed Class H plus retarder and other standard additives. This slurry was mixed at a density of 16.74 ppg and was intended to remain inside the shoe track at the bottom of the casing. As such it was meant to provide a high-quality, high-compressive-strength flow barrier inside the shoe track at the bottom of the casing. When this slurry was pumped, it was immediately on top of and in contact with the 66 percent-quality foam cement that had a density of about 6 ppg near the surface. The heavier slurry, being on top of the foam cement slurry, was gravitationally unstable and thus could have fallen into the lighter foam. The tail cement might have fallen all the way through the foam, unless it was stopped by viscous forces, or it might have mixed with the foam and changed the quality of the foamed cement. In either event, the tail cement slurry remaining inside the shoe track at the end of pumping would be dispersed in the foam and would not retain its intended composition; that is, there would be no concentration of dense tail cement inside the casing as originally planned (see Figure 2-5, right side).

Finding 2.4: The sequence of fluids used to cement the Macondo well included a low-density foamed slurry followed by a dense un-foamed tail slurry. The foam cement was designed to have a density of 14.5 ppg at the bottom of the well, but at the surface, where the foam was mixed, the density was extremely light at around 6 ppg. The tail slurry had a density of 16.7 ppg. Because of the extreme density imbalance, the heavy tail cement on top of the foamed cement would have been gravitationally unstable near the surface, and it probably fell into and perhaps through the foamed slurry. This would have had the unintended effect of leaving a tail slurry containing foamed cement in the shoe track at the bottom of the casing rather than leaving the heavy, un-foamed tail cement.

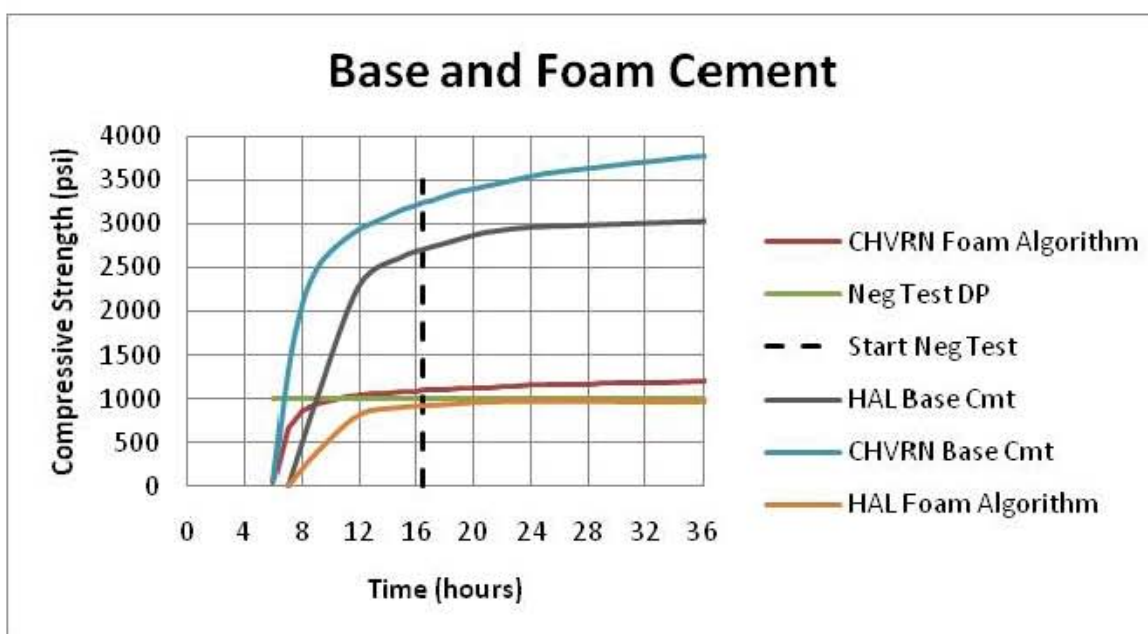
Figure 2-7 shows the time at which the negative pressure test was started after cement slurries were pumped into the Macondo well. The figure also shows a differential pressure of about 999 psi that was created between the reservoir pressure and the reduced hydrostatic pressure inside the casing during the negative test (see Appendix C for the calculation). Figure 2-7 indicates that the foamed cement using the Chevron data would have just barely established the strength required to resist crushing under the differential pressure imposed by the negative test, assuming that the cement was not contaminated or altered by other events. The foamed cement using the Halliburton base data and the foam algorithm would not have achieved sufficient compressive strength. The positive pressure test⁸ of the casing that was performed before the negative pressure test would not have affected the cement because the cement plugs within the well would have supported this increased pressure.

FIGURE 2-7 Uncontaminated cement compressive strength tests (DP = differential pressure). Source: Committee.

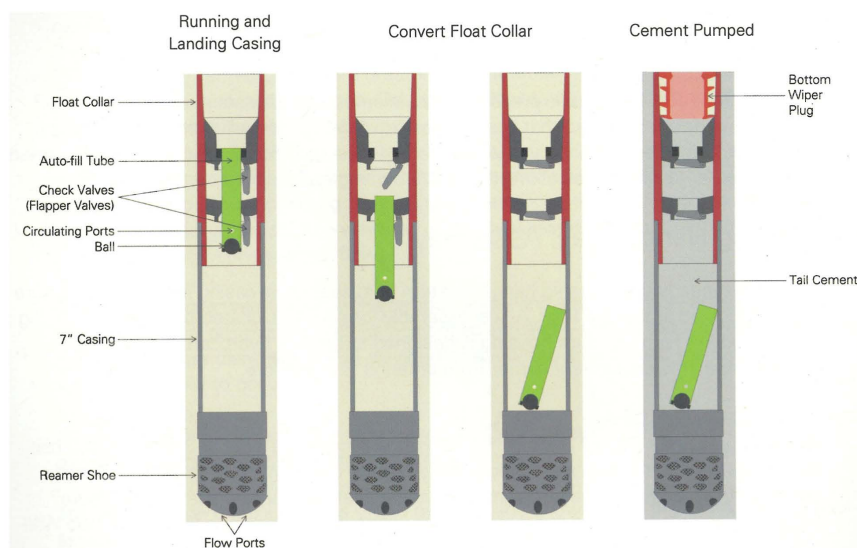
FIGURE 2-8 Float collar with flapper valves and differential fill tube. Source: BP 2010, p. 71. Reprinted with permission; copyright 2010, BP.

Several factors pointed to the probable failure of the flapper valves in the float collar. Once circulation was established, the pump rate never exceeded 4 barrels per minute (bpm), when at least 5 bpm was needed to shear the differential fill tube holding the flapper valves open. This indicates that the flapper valves likely remained open. Another possibility is that sufficient debris remained inside the shoe track to prevent the tube from falling out of the floats but allowing the ball to be pumped out the end of the tube. A third possibility is that the flappers in the valves were damaged when the higher pressure cleared the plug in the casing.

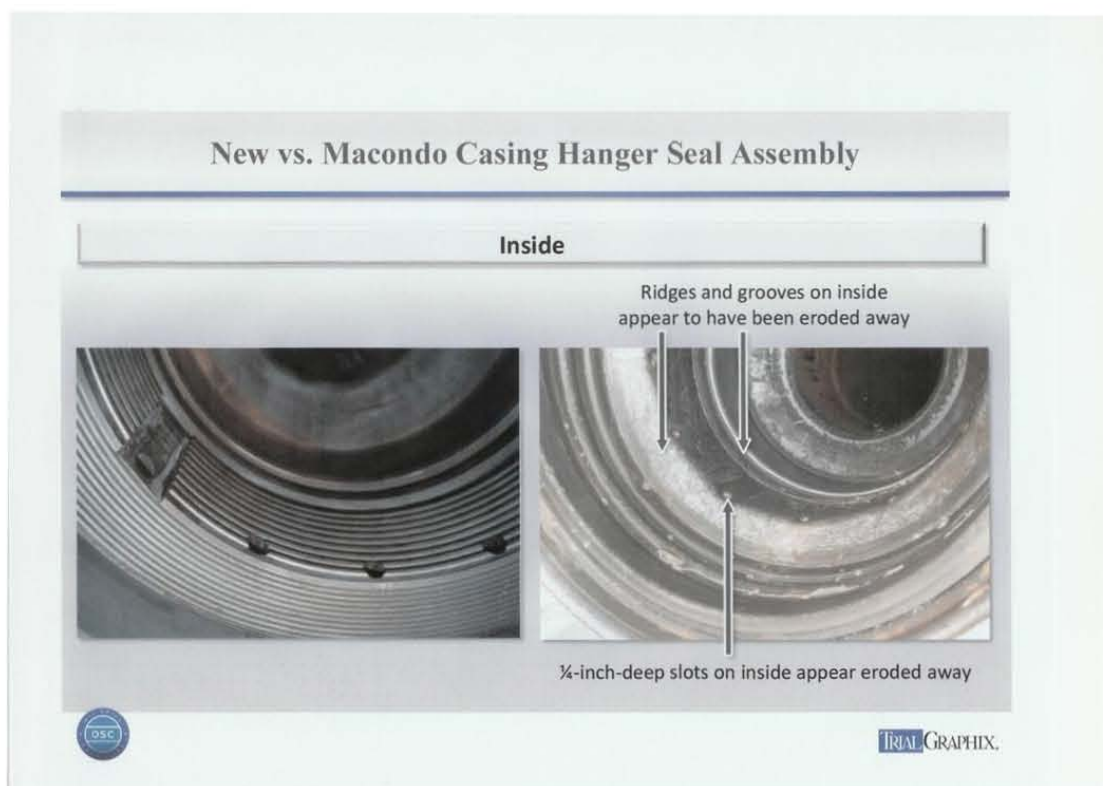
FIGURE 2-9 View inside casing hanger. Source: National Oil Spill Commission, Presentation on the BP *Deepwater Horizon* Oil Spill and Offshore Drilling, Slides 118-120.

There are alternative possibilities for the point of entry into the casing. As discussed above, the most likely possibility appears to be the combination of weak cement inside the casing and leaking flapper valves in the float collar. Another option would be for a split to have formed in the casing at some point. A review of the casing design and the pressure to which the casing was subjected makes this possibility unlikely. In addition, the closing cementing plug was displaced to the top of the float collar with the correct volume of fluid and held pressure when the plug landed on the float collar. This would not have occurred had a split formed in the casing above the float collar.

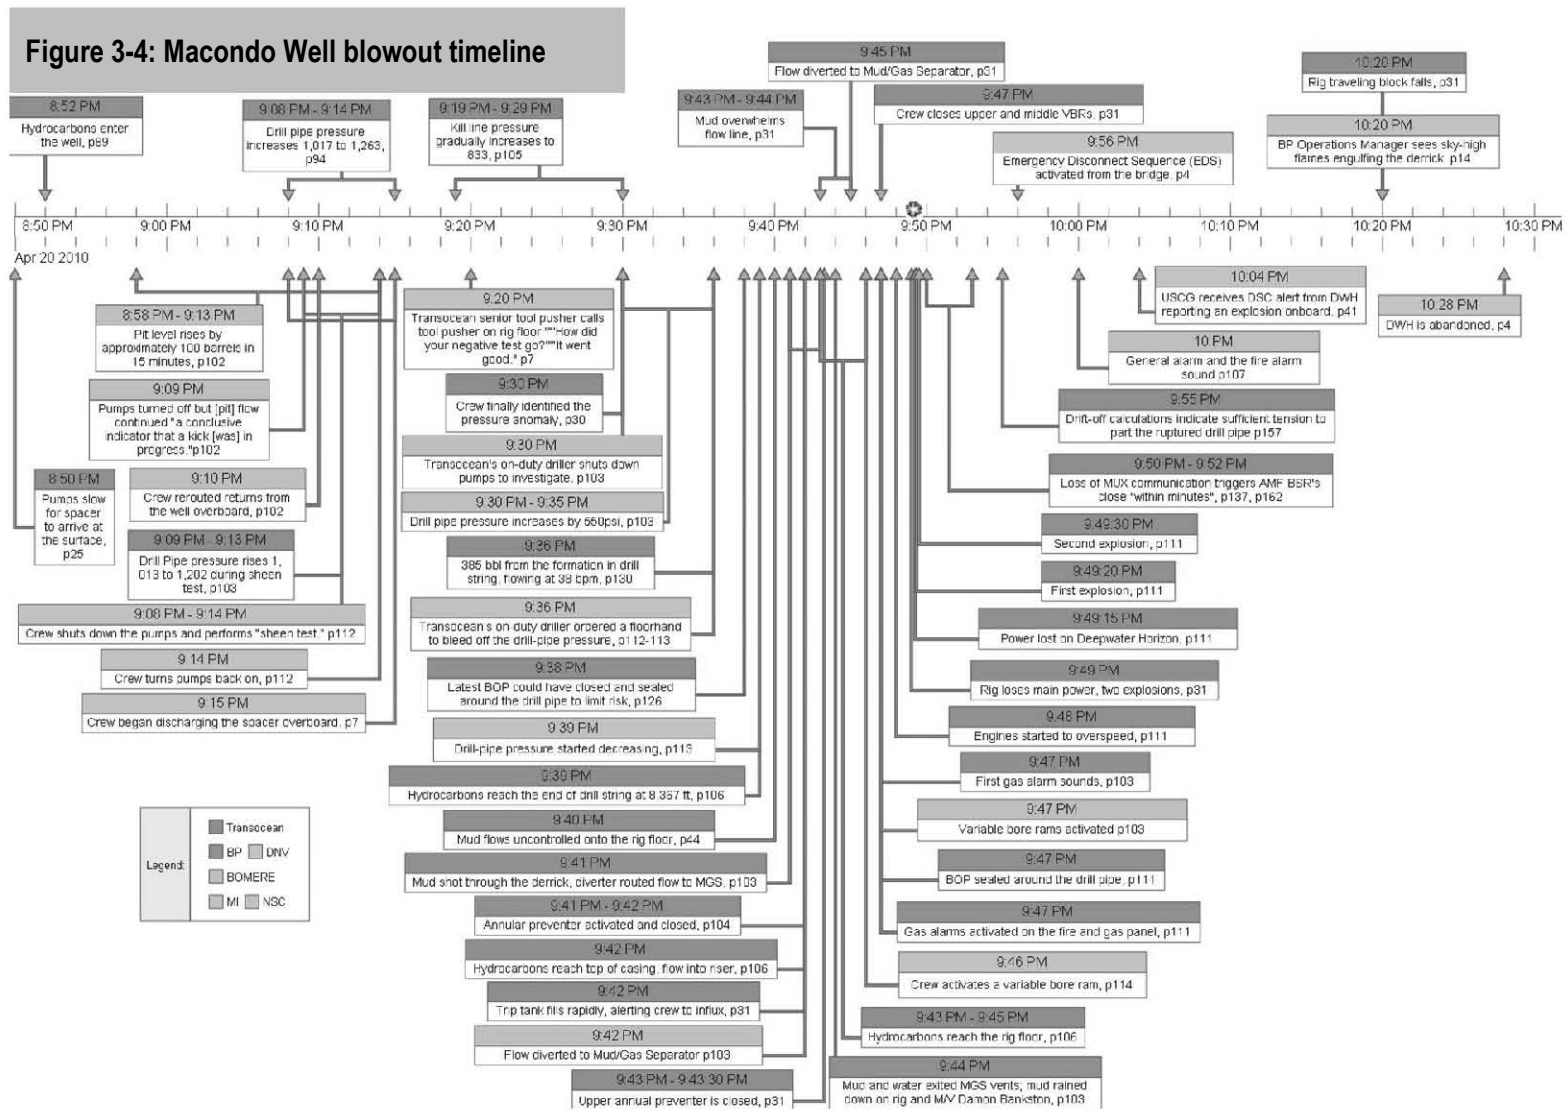
As discussed in Chapter 2, the crew of the *Deepwater Horizon* did not recognize the signs of the impending blowout in time to take the appropriate action. Several indicators that should have alerted the crew that hydrocarbons from the reservoir were flowing into the well were missed, such as the following:

- *The continuing rebound in drill string pressure:* The drill pipe had unexplained and uninvestigated trapped pressure during the third negative test.
- *Excessive returns volume:* The volumes of fluid that flowed from the well during the negative pressure tests exceeded the volume necessary to account for fluid compressibility, and the flow out from the well exceeded the flow in during displacement of mud from the riser.
- *Several unexplained irregularities in pump pressure during and following the displacement of mud.*

FIGURE 3-4 Macondo well blowout timeline. Source: Committee.

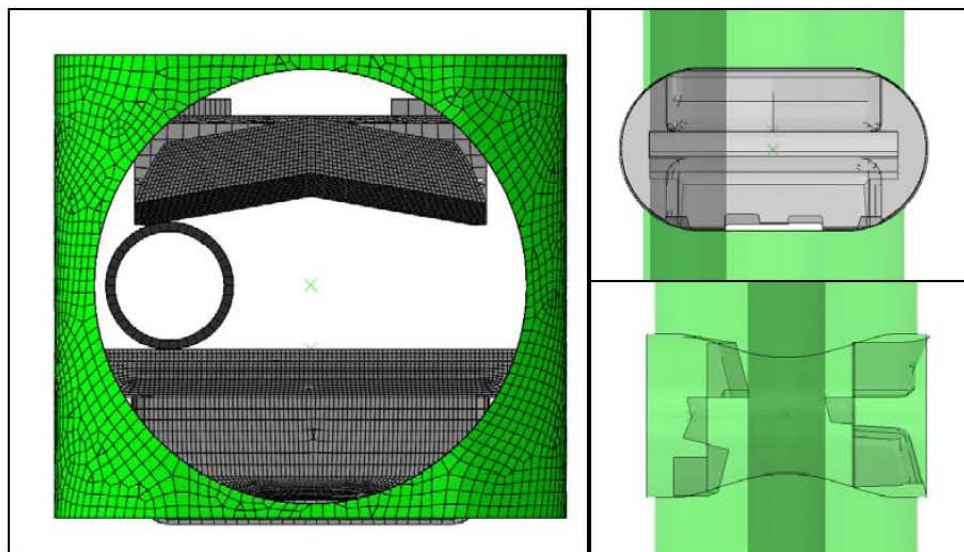
The central finding of the DNV report was that the BSR blades' could not shear a 5½-inch drill string and then seal against each other because the drill string was located on the side and not the center of the BOP annulus. This finding appears to be strongly supported by a wide range of corroborating physical evidence, and it has been embraced by Transocean (Transocean 2011, I, 137). The asymmetric dents in the drill pipe sheared by the rams [impressed into steel 0.350inch thick (DNV 2011a, I, 128)] credibly matched to the geometry of the ram blocks (DNV 2011a, I, 100) leave little room for alternative explanations. In addition, there is compelling physical evidence that the upper annular preventer above the BSR and the VBRs below the BSR were activated and closed on the drill string before the BSR was activated, centering the drill string in the BOP annulus in close proximity to the BSR. Thus, the DNV conclusion that the drill string was under significant compressive load also appears logical and perhaps the only feasible mechanism for pushing the drill string so far off center in such a short distance (27.3 feet) (DNV 2011a, I, 151). The consequence of not extending the blades on the BSR to cover the complete BOP annulus can be clearly observed in Figure 3-5. As was noted earlier, West Engineering dropped the one straight and one V blade BSR configuration from its study in 2004 because of the higher shearing pressure this design required. It is also apparent that this configuration had less ability to center an off-center drill string than a double V ram design would have evidenced. The gaps on the sides of the BSR blades, and their obvious inability to shear any pipe that was in this area, indicate that the possibility of pipe being off center was not considered in this design.

The source of the high compressive load on the drill string causing the “elastic buckle” (DNV 2011a, I, 150) driving it to the side of the annulus, calculated by DNV to be in excess of 113,000 pounds (DNV 2011a, I, 153), was not definitively determined. However, among a number of possible sources that it considered for this load, DNV hypothesized the following: “Forces from the flow of the well induced a buckling condition on the portion of drill pipe between the Upper Annular and Upper VBRs” (DNV 2011a, I, 174). Further complicating the determination of the compressive load source is uncertainty about exactly when the BSR was activated, since different sources of compressive drill string load are potentially available only at certain times in the failure sequence. Two distinct BSR activation times have been hypothesized by the parties involved. Transocean maintains that both the blue (Transocean 2011, I, 159) and the yellow (Transocean 2011, I, 158) control pods were functional and available at the time of the explosion and loss of MUX and hydraulic connection to the *Deepwater Horizon* at 21:49, and therefore the AMF was functional and functioned “within minutes” (Transocean 2011, I, 162) on April 20. However, BP and DNV have hypothesized, on the basis of the retrieved condition of the blue pod batteries (BP 2010, 150, 153) [74 days after the explosion (Transocean 2011, I, 159)], and the incorrectly wired Solenoid 103 on the yellow pod (BP 2010, 150), that BSR activation was more likely due to the autoshear function, which bypasses Solenoid 103 and was caused by ROV intervention at 07:30 on April 22 (Transocean 2011, I, 162).

FIGURE 3-5 Finite element analysis model of BSR blade surfaces and off-center drill pipe. Source: DNV 2011b, p. 15. Reprinted with permission; copyright 2011, DNV.

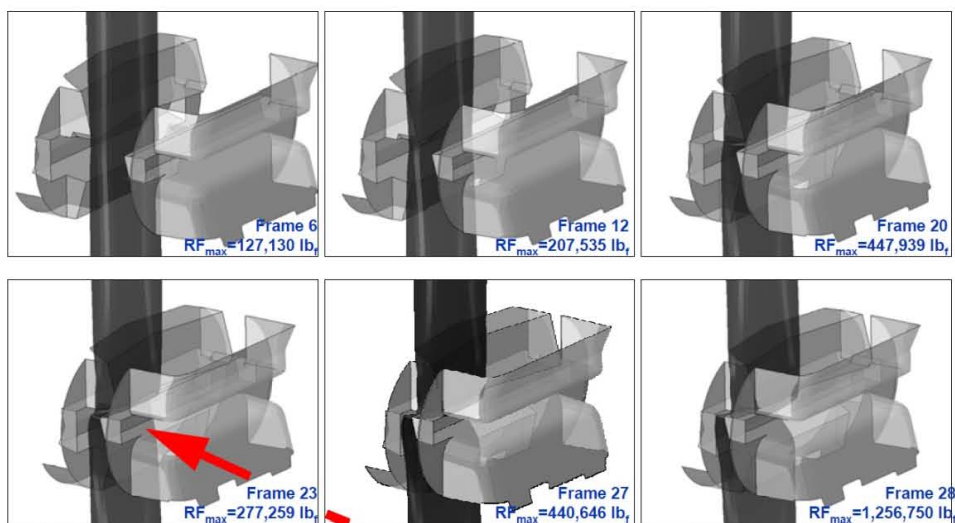
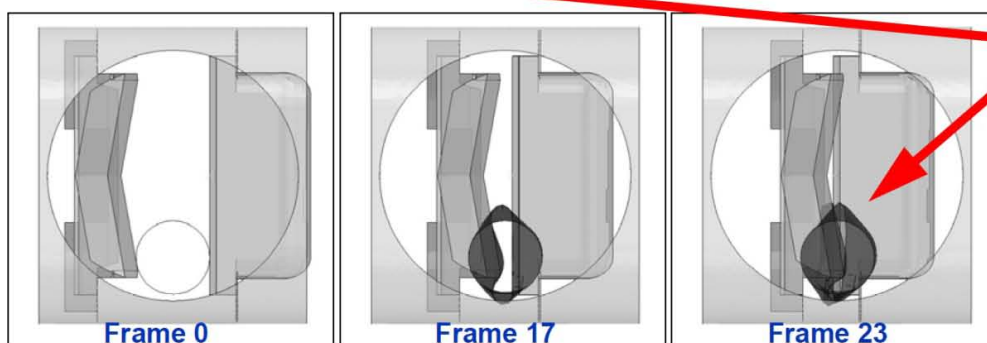
Revised Figure 140 Progression of Off-Center BSR Shear Model - Isometric View

The weight of the evidence appears to support the conclusion of BP and DNV that the BSR was activated by the autoshear, but for additional reasons not addressed in their reports. All parties appear to agree that the upper and middle VBRs successfully sealed the well a minute or two before the explosions, accounting for the large pressure spike in the drill string starting at 21:47 (BP 2010, 105). Both these VBRs were found with their ST locks set (DNV 2011a, I, 31), meaning that they stayed applied, irrespective of flow or pressure, until the BOP was retrieved. Thus, until they were eventually eroded, the annulus of the BOP remained sealed by these VBRs. During this period the only flow path for hydrocarbons from the formation to the rig was the drill string. If Transocean was correct, this flow path was interrupted “within minutes” by the AMF activating the BSR. It appears undisputed that the BSR sheared the drill string off center in the manner illustrated by Figure 3-6, which is from the DNV report addendum (DNV 2011b, 17). If Transocean is correct and the AMF functioned “within minutes” of 21:50, then the entire hydrocarbon communication with the Macondo well must have been through the small flow area that would exist at that time from the sheared end of Pipe Segment 94 (End 94B) (DNV 2011a, I, 95). Note on Figure 3-6 in Frame 23 that the sheared pipe end is shown with only 277,000 pounds of ram load applied where the BSR will ultimately apply approximately 900,000 pounds of ram force at the regulated pressure of 4,000 psi (DNV 2011a, 14). Thus, substantially less cross-sectional flow area will be available to well hydrocarbons than is shown in Frame 23.

Total flow area available from the well with VBRs sealed until the drill pipe erodes with only $\sim 1/3$ the ultimate ram closing load applied.

FIGURE 3-6 Progression of off-center BSR shear model, isometric view (*top*) and top view showing deformation of drill pipe outside of shearing blade surfaces (*bottom*). Source: DNV 2011b, p. 17. Reprinted with permission; copyright 2011, DNV.
