Macondo Well-Deepwater Horizon Blowout: Lessons for Offshore Drilling Safety

Macondo Well–*Deepwater Horizon* Blowout: Lessons for Improving Offshore Drilling Safety

Committee for Analysis of Causes of the Deepwater Horizon Explosion, Fire, and
Oil Spill to Identify Measures to Prevent Similar Accidents in the Future

NATIONAL ACADEMY OF ENGINEERING *AND*
NATIONAL RESEARCH COUNCIL

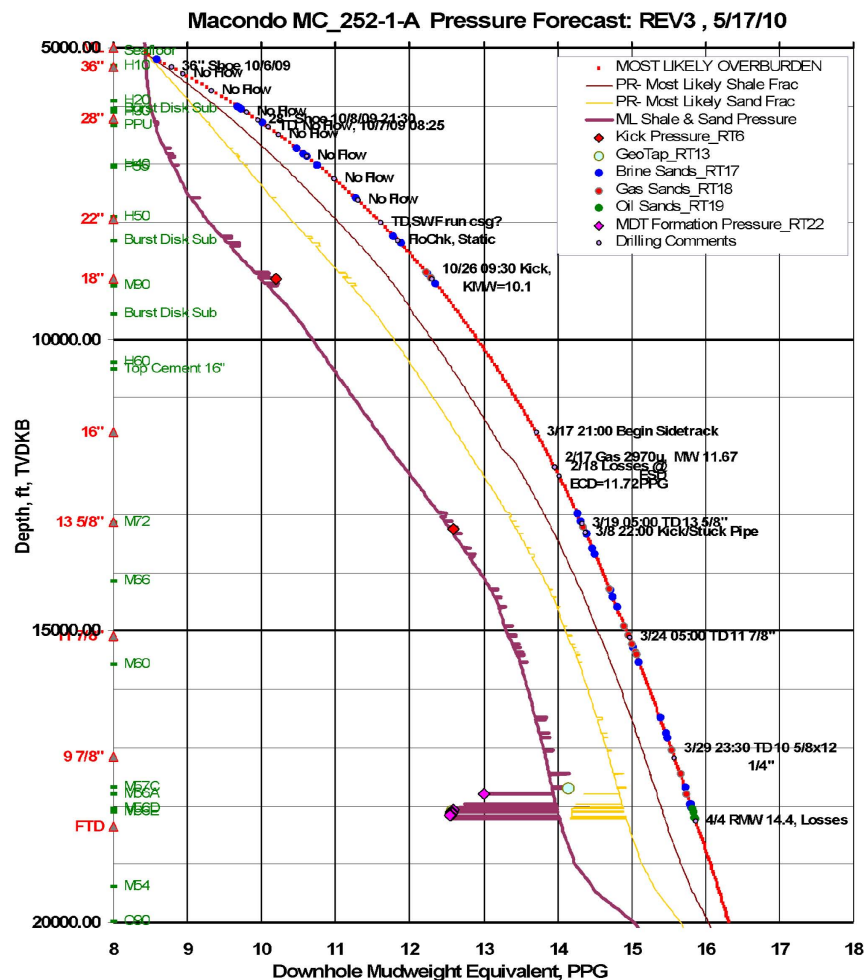
2. In the course of drilling at 13,250 feet, a kick occurred, and the lower annular blowout preventer (BOP) was closed in response. During well control operations, the drill string became stuck and was severed at 12,147 feet. The drill string and hole below 12,147 feet were abandoned, and subsequent well drilling deviated slightly to go around the abandoned materials left in the original hole. The 13 $\frac{5}{8}$ -inch liner was run at 13,145 feet, which was shallower than planned, to allow the well to be drilled safely past the higher pressure reservoir that had been encountered. The 11 $\frac{7}{8}$ -inch liner was used at 15,103 feet to seal the reservoir and allow for the use of higher mud weights than had been anticipated. Mud weight was to be kept between the curves for pore pressure and fracture pressure, as shown in Figure 2-3.

FIGURE 2-3 Overburden stress, fracture gradients in the shale and sands and pore pressure in the Macondo well. The equivalent mud weight (EMW), expressed in pounds per gallon (ppg), must be higher than the pore pressure to avoid flow from the well and lower than the fracture gradient to prevent accidental hydraulic fracturing. Note the small separation between the values at depths below 18,000 ft. Source: BP Post-Well Subsurface Description of Macondo well (MC0252_1BP1) v3. July 26, 2010. Reprinted with permission; copyright 2010, BP.

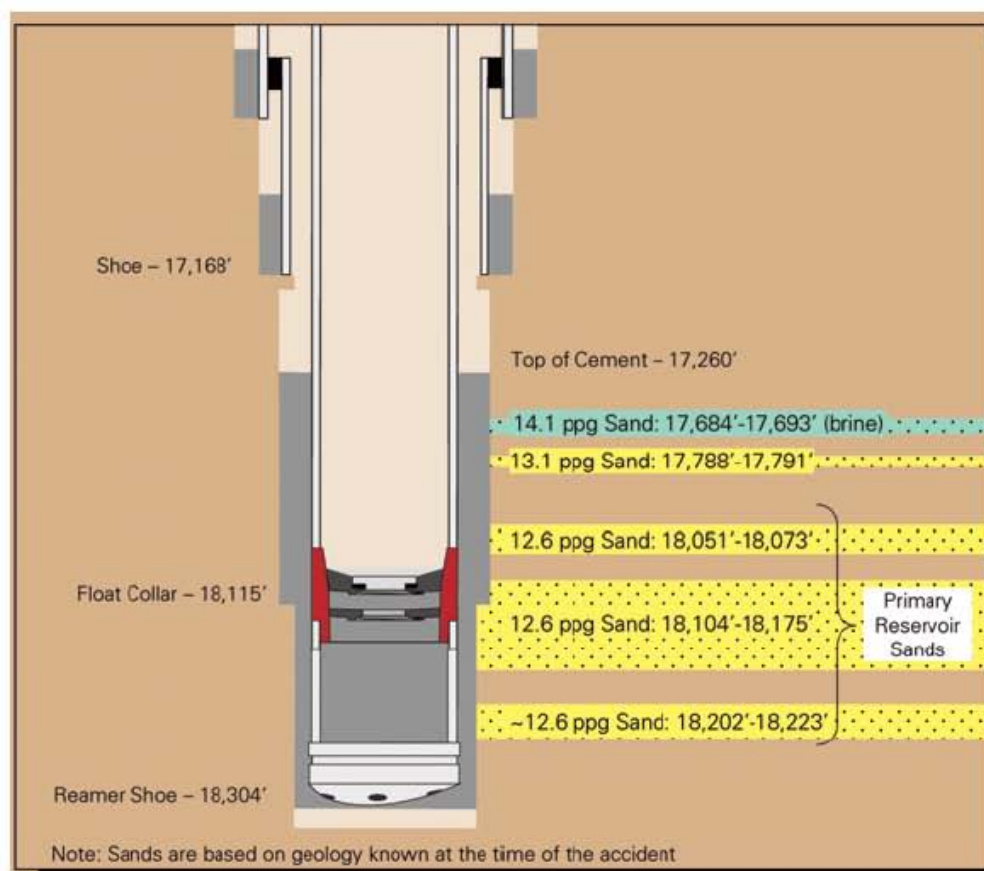
between the mud weight needed to prevent salt water flow and the mud weight, above which reservoir fracture could occur was only 0.2 ppg. Recent reports in the press have indicated that a thin gas sand was present above the salt water bearing zone shown in Figure 2-4 and have questioned the possible contribution of this sand to the blowout. The committee has seen no evidence indicating that flow occurred upwards in the annulus between the production casing and the reservoirs (see discussion below). Also, the presence of the high-pressure salt water sand created the same completion problem referenced above as would have been created by the presence of a high pressure gas sand. Therefore, the presence or not of the gas sand is expected to have had no material effect on the cause of the blowout.

To continue drilling to the planned final depth of 19,650 feet, the reservoirs that had been discovered with decreasing pore and fracture pressures with depth (Figure 2-4) were to be sealed with the 9 $\frac{7}{8}$ inch \times 7-inch combination casing string and cement. However, because the hole diameter that could be drilled below the 7-inch casing was considered too small to be practical, so the well was terminated at 18,360 feet.

FIGURE 2-4 Variation of pore pressure in the open hole section of the Macondo well expressed in pounds per gallon. Source: BP 2010, p. 54. Reprinted with permission; copyright 2010, BP.

According to the BP accident investigation report (BP 2010), the final open hole section of the well contained several reservoirs with decreasing pore pressure with depth. As shown in Figure 2-4, the largest pore pressure was estimated at 14.1 ppg in a salt-water-bearing reservoir, and the lowest was estimated at 12.6 ppg in the hydrocarbon-bearing reservoir. The largest pore pressure required that the mud weight be at least this high to prevent salt water flow from the reservoir. The fracture mud weight was just above 14.2 ppg, as evidenced by lost circulation at 18,260 feet (see BP 2010, 17-18 and Figure 2-3). This caused the margin of safety between the equivalent circulating density (ECD)⁴, shown in Figure 2-3 as an equivalent mud weight, and the fracture mud weight to be very small. The operations associated with pumping cement into the annulus without fracturing one of the lower-pressure reservoirs were therefore difficult.

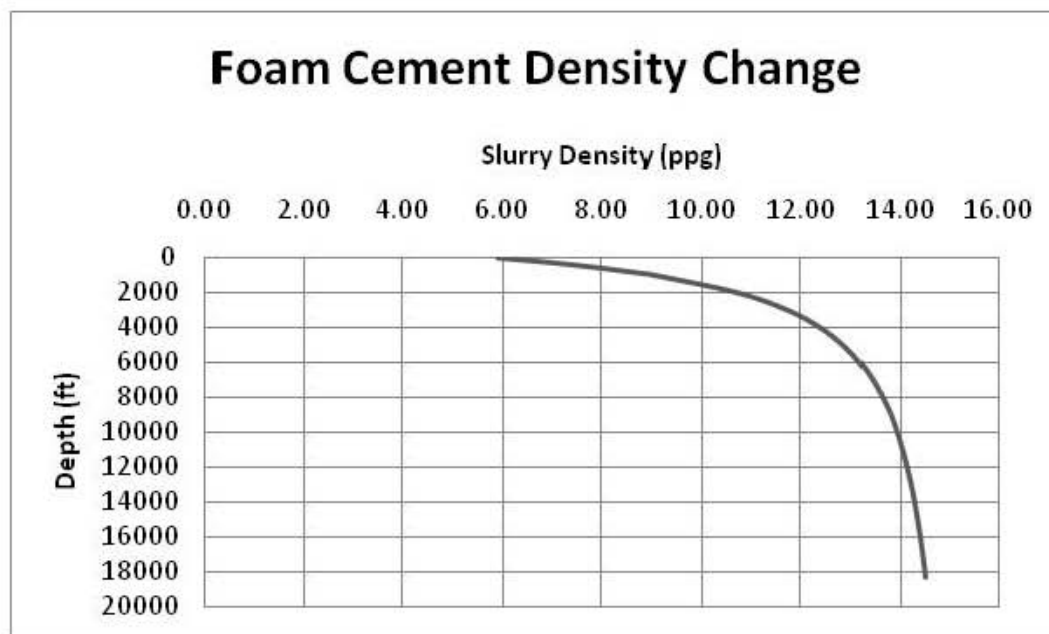
To make a foamed cement slurry that has a density of 14.5 ppg at the bottom of the well, the foam quality⁶ had to be 17.4 percent at bottom hole conditions of 245°F and 13,321 psi (see Appendix C for the calculations).⁷ At the surface, where the conditions in the mixer were about 600 psi and 60°F, the foam quality had to be 66 percent, producing a foamed slurry of about 6 ppg, to allow for the substantial compression and heating that were to occur as the foam was pumped to the bottom of the well. (For reference, fresh-water has a density of 8.33 ppg.). Figure 2-6 shows the calculated foam density versus depth.

FIGURE 2-6 Calculated foam density versus depth during pumping. Source: Committee.

Finding 2.4: The sequence of fluids used to cement the Macondo well included a low-density foamed slurry followed by a dense un-foamed tail slurry. The foam cement was designed to have a density of 14.5 ppg at the bottom of the well, but at the surface, where the foam was mixed, the density was extremely light at around 6 ppg. The tail slurry had a density of 16.7 ppg. Because of the extreme density imbalance, the heavy tail cement on top of the foamed cement would have been gravitationally unstable near the surface, and it probably fell into and perhaps through the foamed slurry. This would have had the unintended effect of leaving a tail slurry containing foamed cement in the shoe track at the bottom of the casing rather than leaving the heavy, un-foamed tail cement.

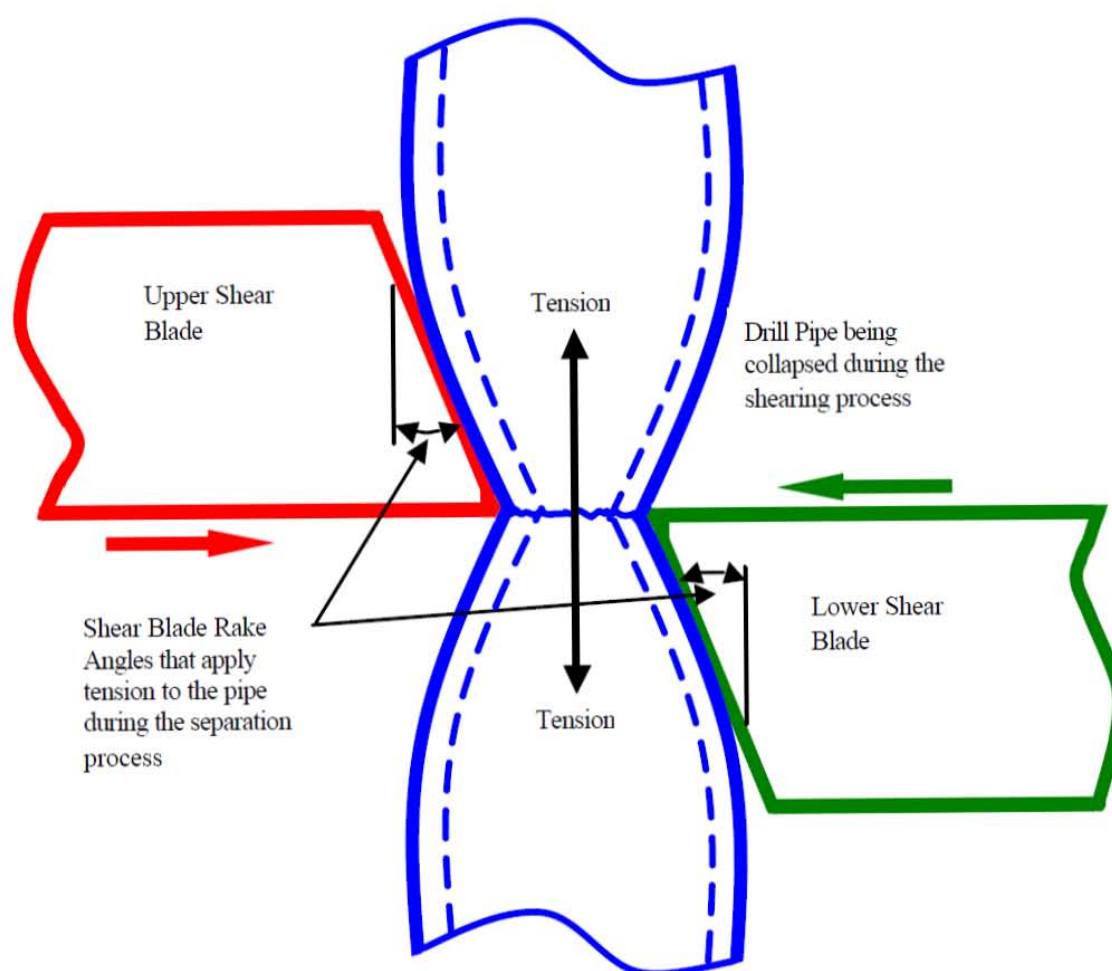
FIGURE 3-3 Upper and lower shear blades crushing the drill pipe and beginning the shearing (or breaking) operation. Source: West Engineering Services, Inc. 2004, p. 2-2. Reprinted with permission; copyright 2004, West Engineering Services, Inc.

- In the cutting process, the shear rams collapse or mash the pipe, and as the pipe is crushed, the blade angle pulls the metal into tension and breaks it in a tensile mode of failure (Figure 3-3). Depending on the ram blade design, the blade can flatten the pipe to a great extent, which in turn can prevent the ram from closing completely and sealing even if the pipe is centered.

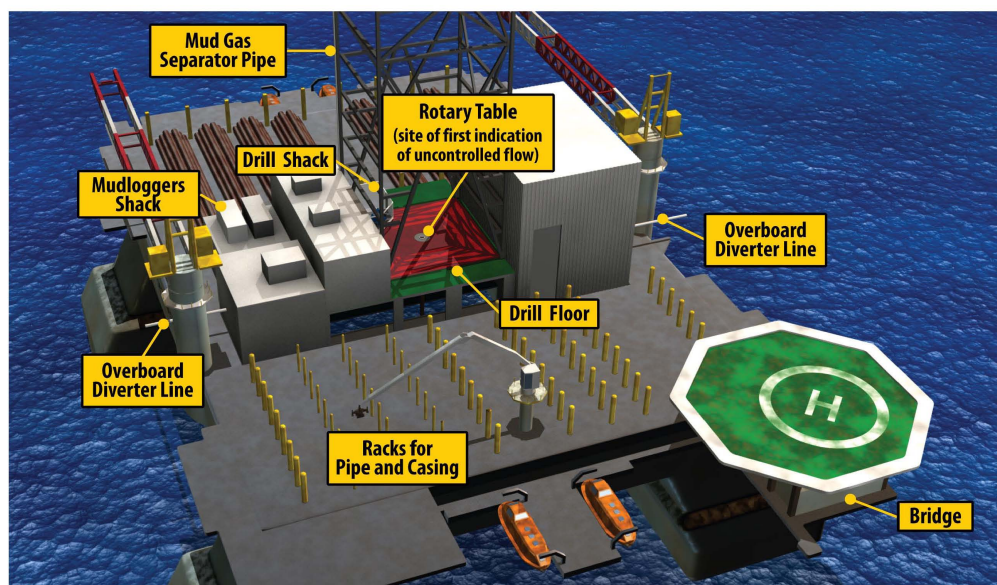
In addition to going straight up through the derrick or through the mud gas separator system vents, the only other path through which uncontrolled hydrocarbon flow could have been directed is through 14-inch diverter lines which were positioned to send the flow overboard at about derrick floor level (see Figure 4-2). Testimony cited above indicates that did not occur, and why that path was not chosen remains an unresolved question.¹³ It is possible, according to BP's analysis, that the overboard diverter flow of hydrocarbons might have delayed the formation of the explosive cloud that surrounded the rig (BP 2010, 128). As the rig suffered from a loss of power, explosions and fire, the bridge team was reacting, but confusion clouded the decision process. The general alarm was manually activated by the dynamic positioning officer, and she sent mayday messages.¹⁴ Senior officers argued about whether the order had been given to initiate an emergency disconnect of the lower marine riser from the blowout preventer (BOP), and were conflicted about who had the authority to issue that order, the Master or the OIM.¹⁵ Before the Master and OIM completed discussions about initiating the EDS, the Subsea Supervisor had already made an attempt to do so, but it was unsuccessful (USCG 2011). The display panels indicated that the disconnect had occurred, but he determined that the MODU was still connected to the riser (USCG 2011).

After accounting for all survivors, it was determined that the eleven killed were crew last seen on the Drill Floor, the Mud Pump Room and the Shaker House. All of those areas were broadly exposed to the gaseous hydrocarbon flow erupting from the well through the mud gas separator system vents.²¹ There was no protection system built into these working areas of the rig to deflect the effects of explosion from those who were exposed.

FIGURE 4-2 Illustration of the main deck of the *Deepwater Horizon*. The rig crew could send fluids from the well overboard through the overboard diverter lines. Alternatively, the crew could route flow from the well to a mud-gas separator pipe and vent hydrocarbon gas before sending the mud to the mud pits (not shown). Source: Chief Counsel's Report 2011.
